# Manhole Inspection Summary

Manhole # S59K\_\_014MH

**Location** Address: **4500 fait ave**

Cross Street: **s lehigh st**

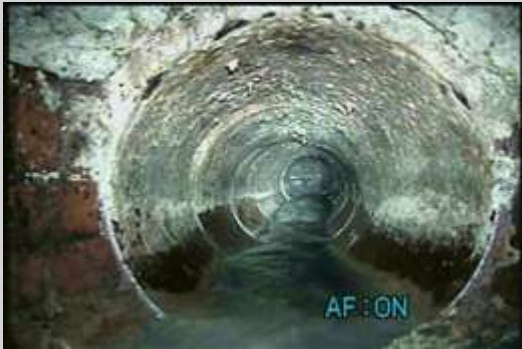
12 O'Clock Outflow

15 in. Circular Gravity Sewer  
Pipe Out @ 12 O'Clock

Deposits: ☒ None ☐ Mud ☐ Sludge ☐ Debris ☐ Grease

Infiltration: **None** Pipe Seal Cond: **Unknown**

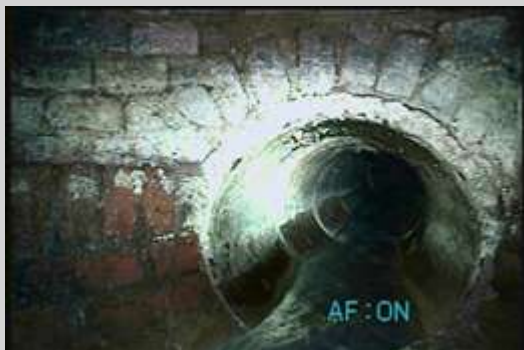
9 O'Clock Inflow

8 in. Circular Gravity Sewer

Pipe In @ 9 O'Clock

Infiltration: **None**
